## **Appendix C**

### **Photograph Log**

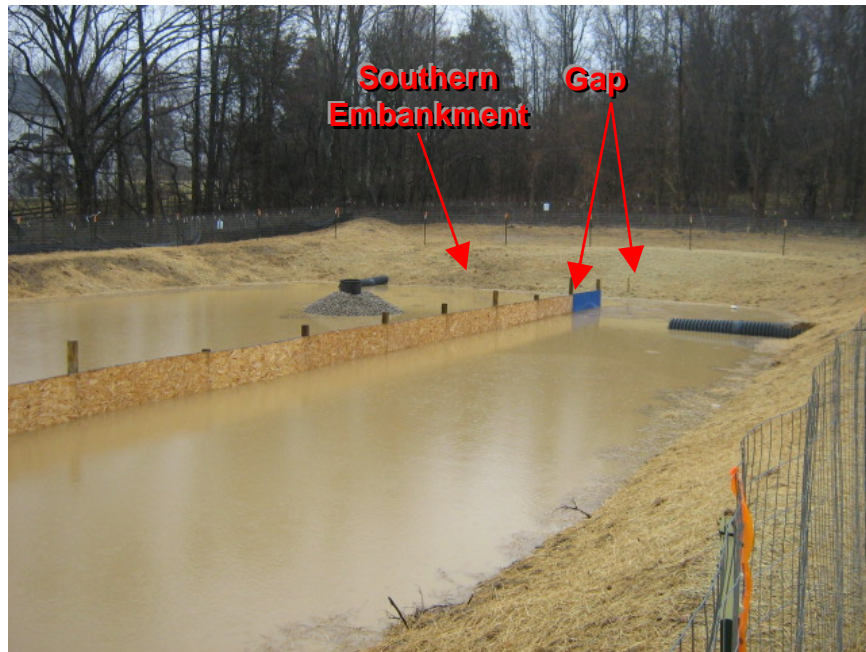
**Photograph 1.**  
facing southeast.

**Shipley Farm – View of Sediment Trap#1 southern embankment,**

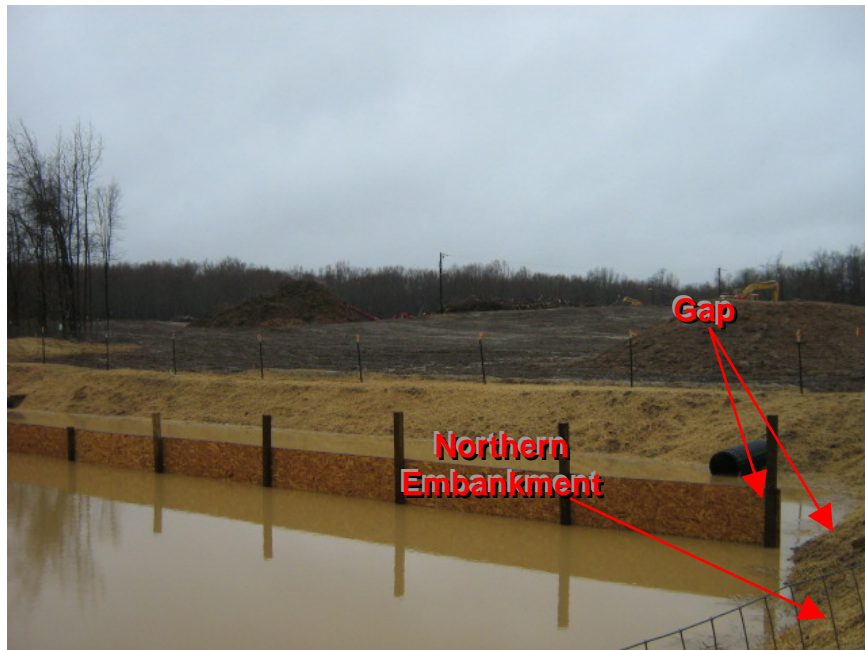
**Photograph 2.**  
facing southwest.

**Shipley Farm – View of Sediment Trap#1 northern embankment,**

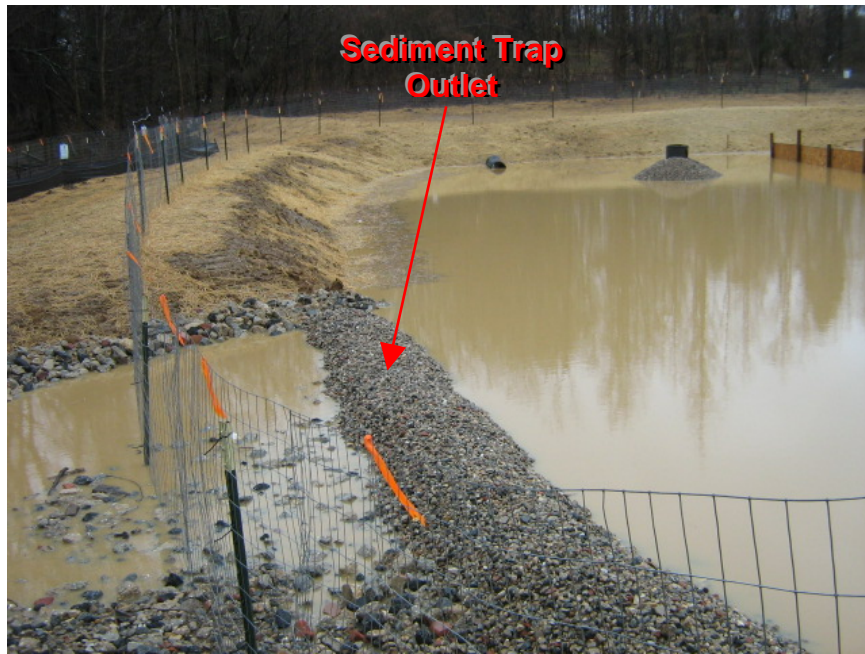
**Photograph 3.** Shipley Farm – Turbid flow discharging from Sediment Trap#1.

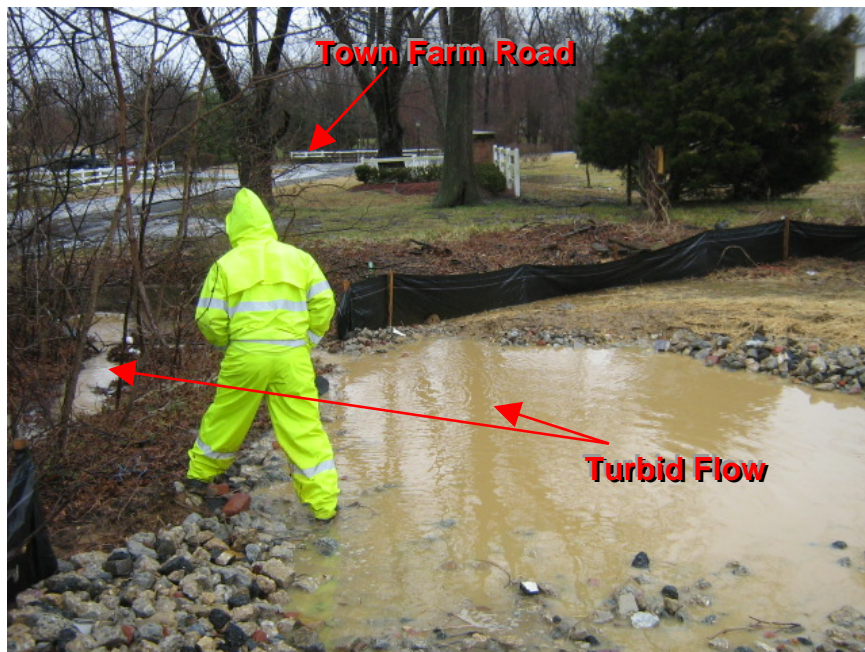
**Photograph 4.** Shipley Farm – View along Sediment Trap#1 outlet channel, facing northeast.

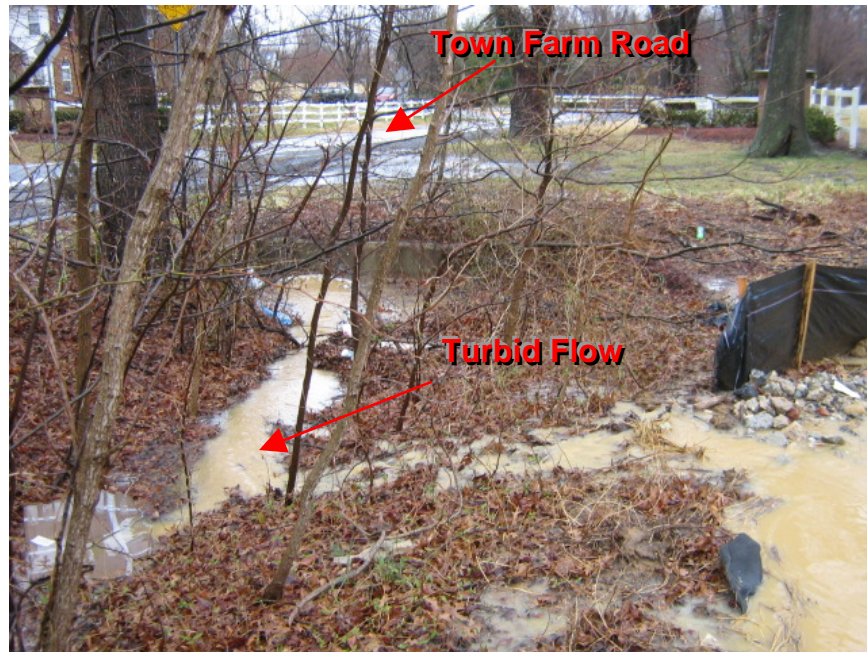
**Photograph 5.** Shipley Farm – Close-up view of area shown in Photograph 4. Note turbid flow discharging from Sediment Trap#1 outlet channel to drainage ditch along Town Farm Road.

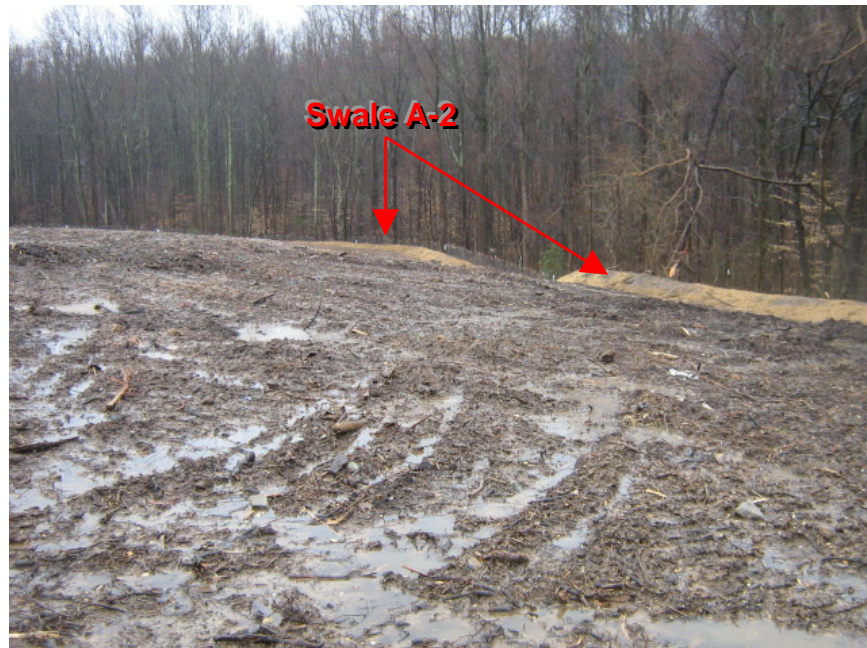
**Photograph 6.** Shipley Farm – View of Swale A-2, which was implemented along the southwest perimeter of the site to direct flow to Sediment Trap#3.

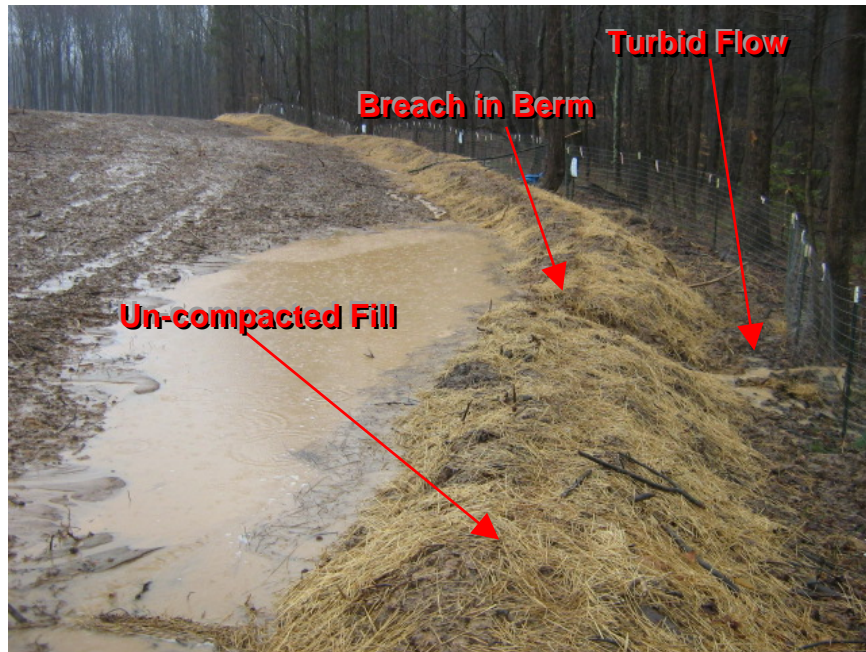
**Photograph 7.** Shipley Farm – View of Swale A-2 showing breach in berm and turbid flow exiting the site.

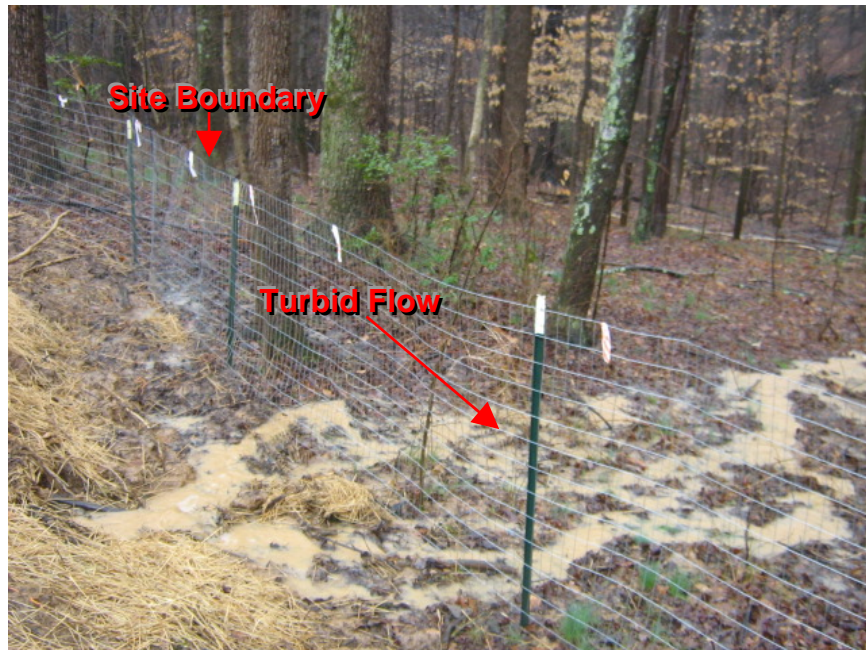
**Photograph 8.** Shipley Farm – Close-up view of area shown in Photograph 7. Note breach in berm and turbid flow exiting the site to the southwest.

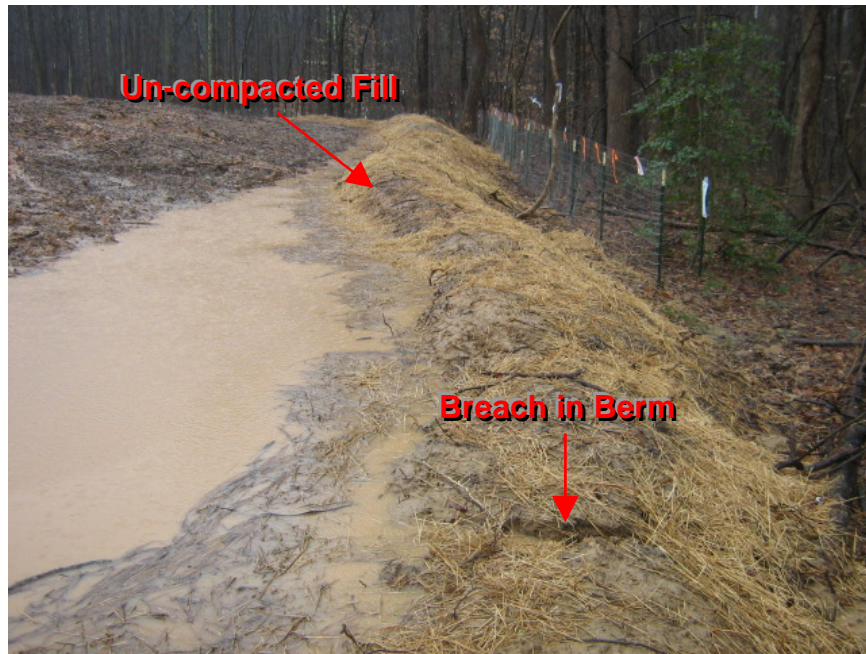
**Photograph 9.** Shipley Farm – A second location along Swale A-2 where the berm had breached.

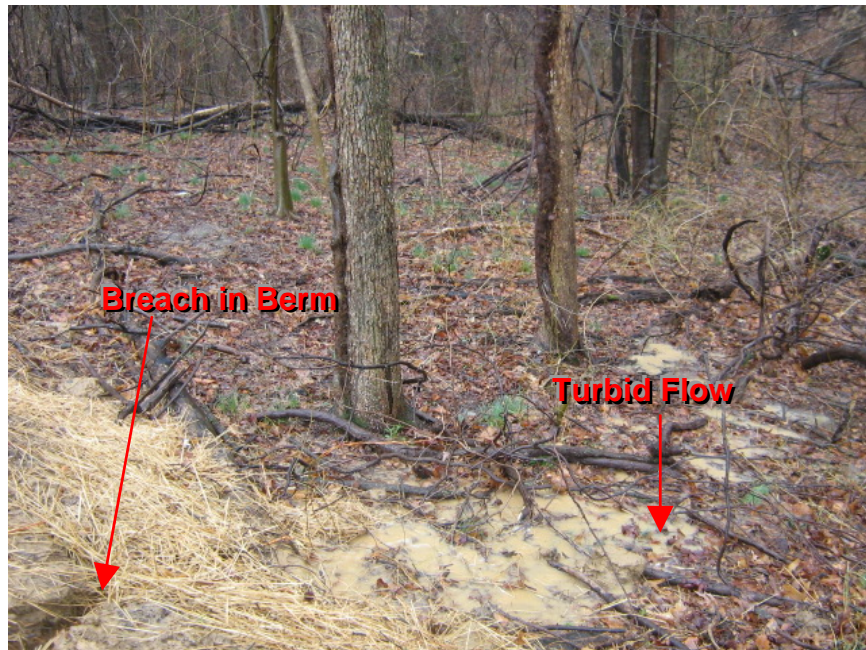
**Photograph 10.** Shipley Farm – Close-up view of area shown in Photograph 9. Note breach in berm and turbid flow exiting the site to the southwest.

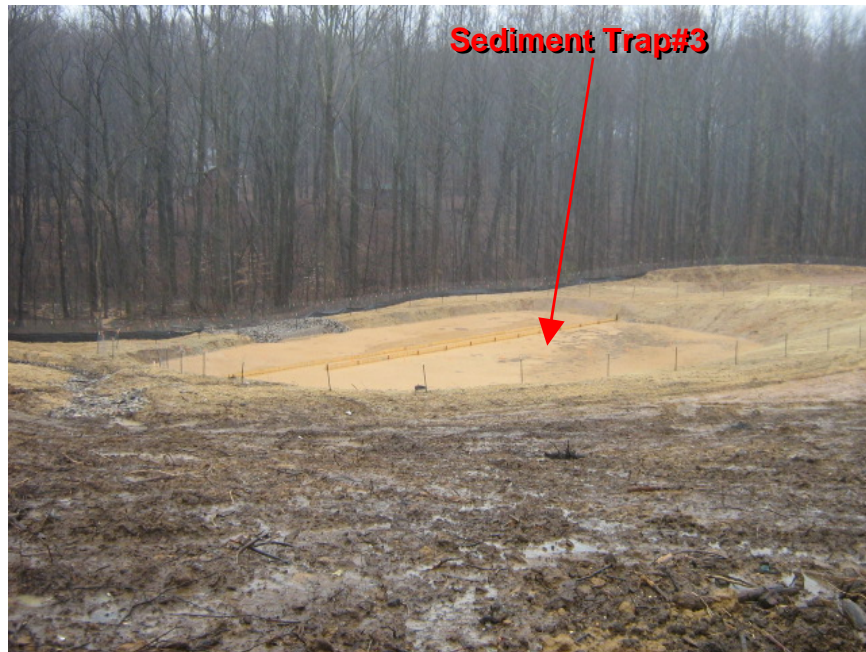
**Photograph 11.** Shipley Farm – View of Sediment Trap#3, facing southwest.

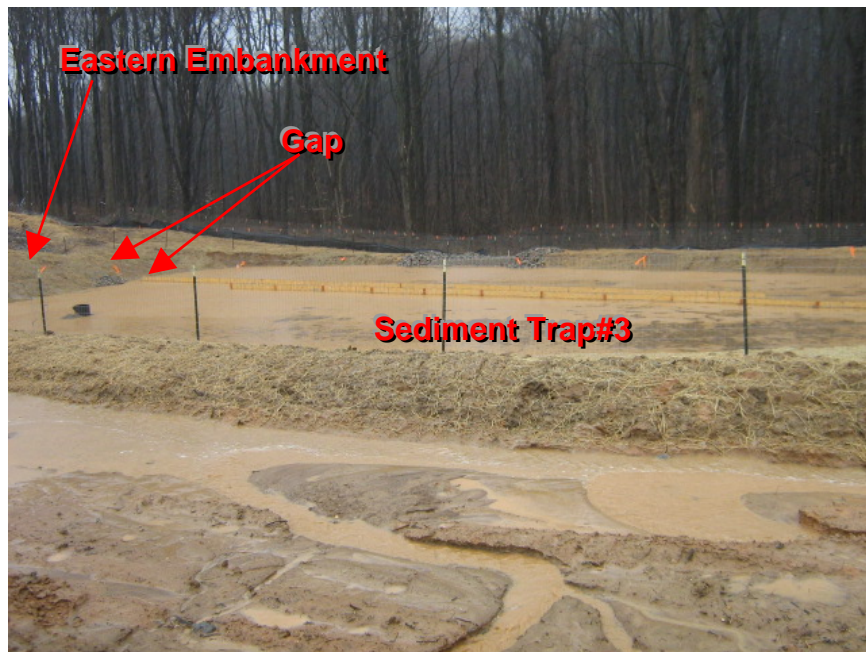
**Photograph 12.** Shipley Farm – View of Sediment Trap#3 eastern embankment. Note that southernmost baffle board was not extended into the eastern embankment.

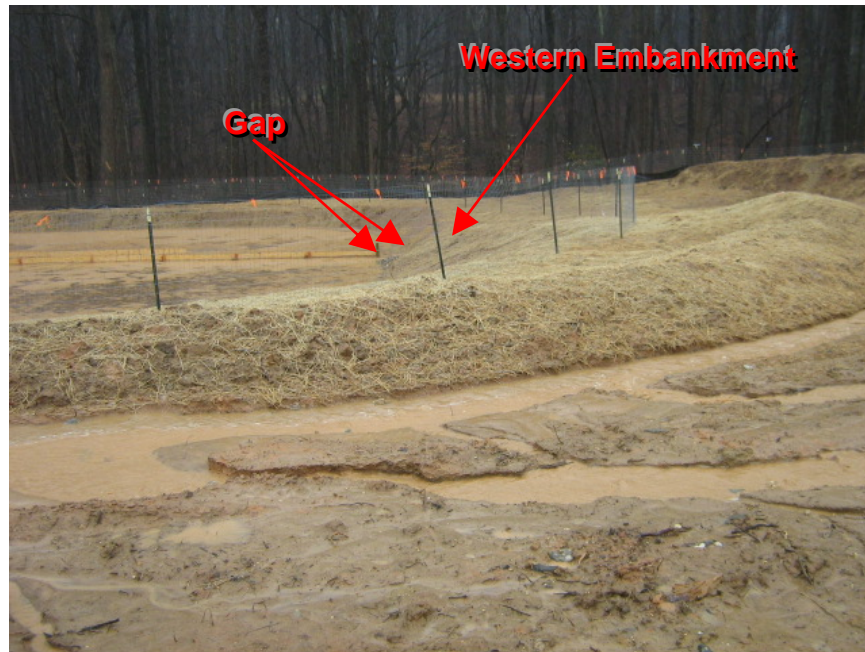
**Photograph 13.** Shipley Farm – View of Sediment Trap#3 western embankment.  
Note that northernmost baffle board was not extended into the western embankment.

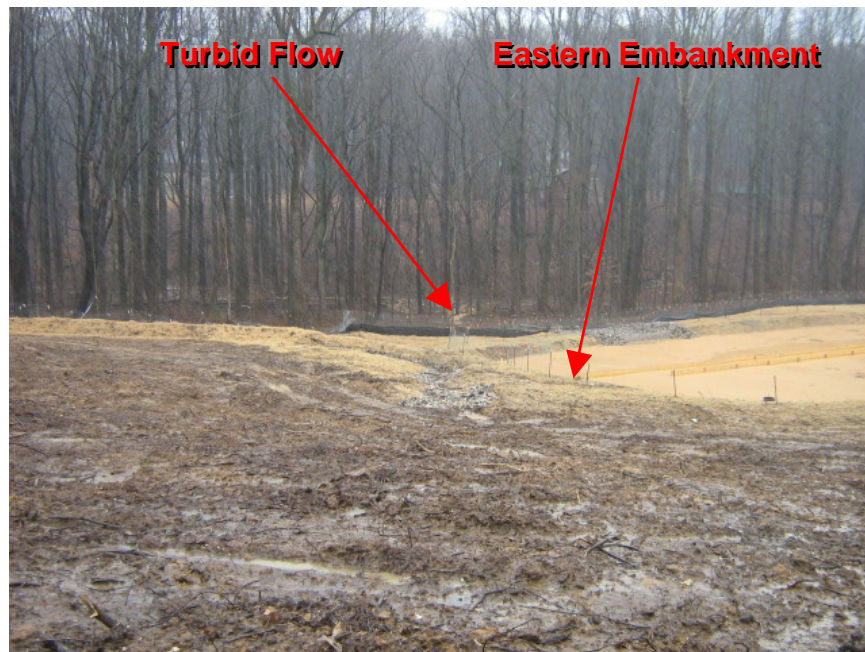
**Photograph 14.** Shipley Farm – View of Sediment Trap#3 eastern embankment.

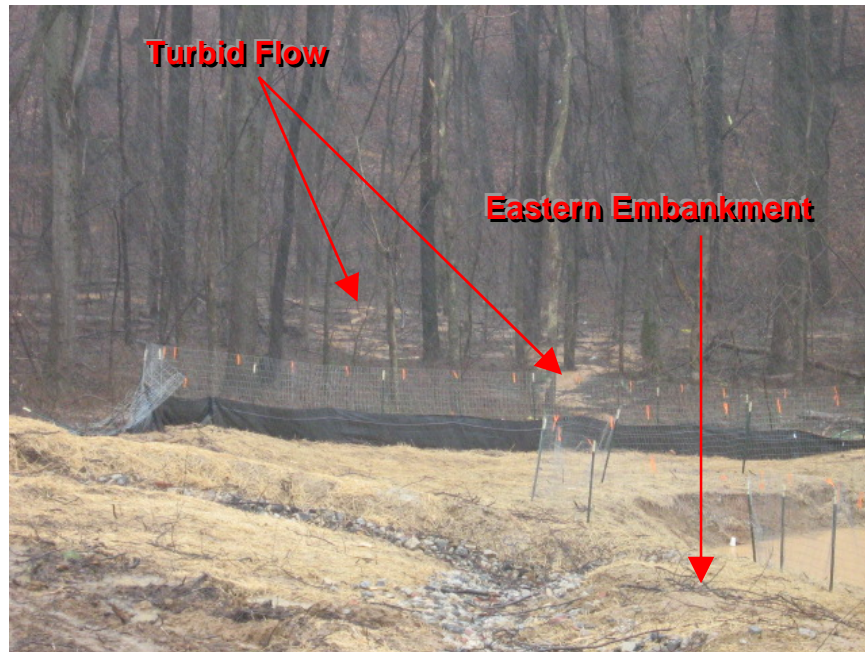
**Photograph 15.** Shipley Farm – Close-up view of area shown in Photograph 14. Note turbid flow exiting the site to the southeast.

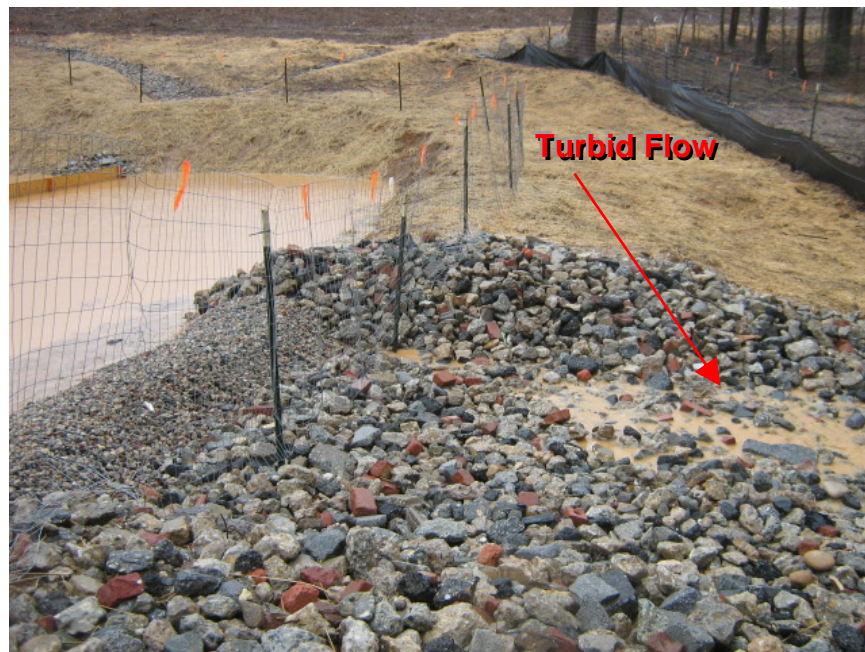
**Photograph 16.** Shipley Farm – View of Sediment Trap#3 outlet and turbid flow.

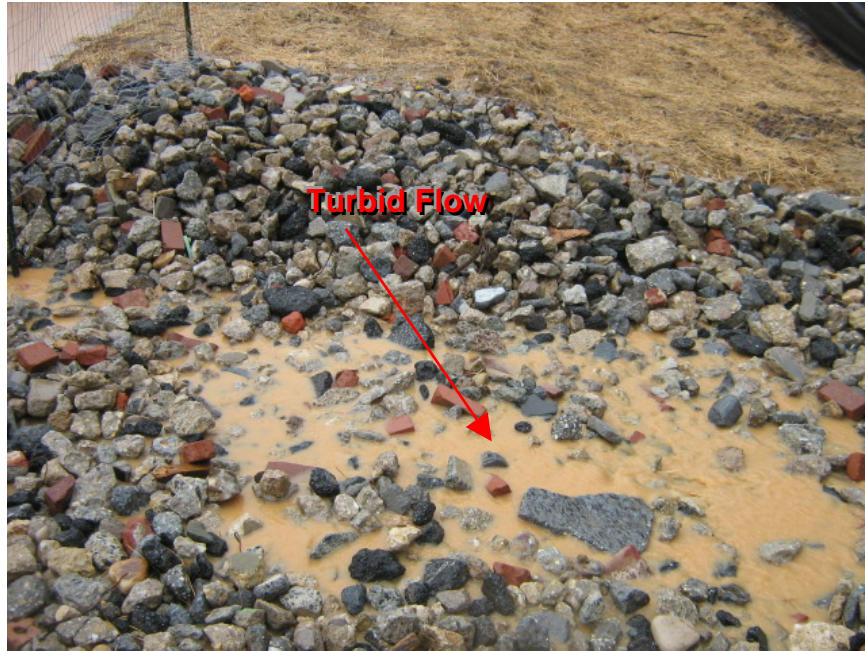
**Photograph 17.** Shipley Farm – Close-up view of Sediment Trap#3 outlet and turbid flow.

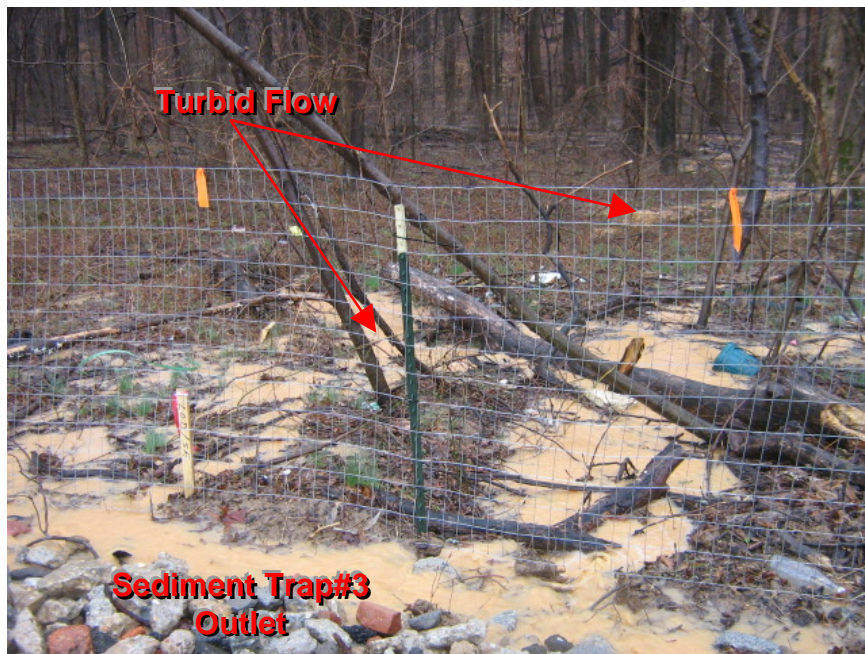
**Photograph 18.** Shipley Farm – View of Sediment Trap#3 outlet. Note turbid flow exiting the site to the southeast.

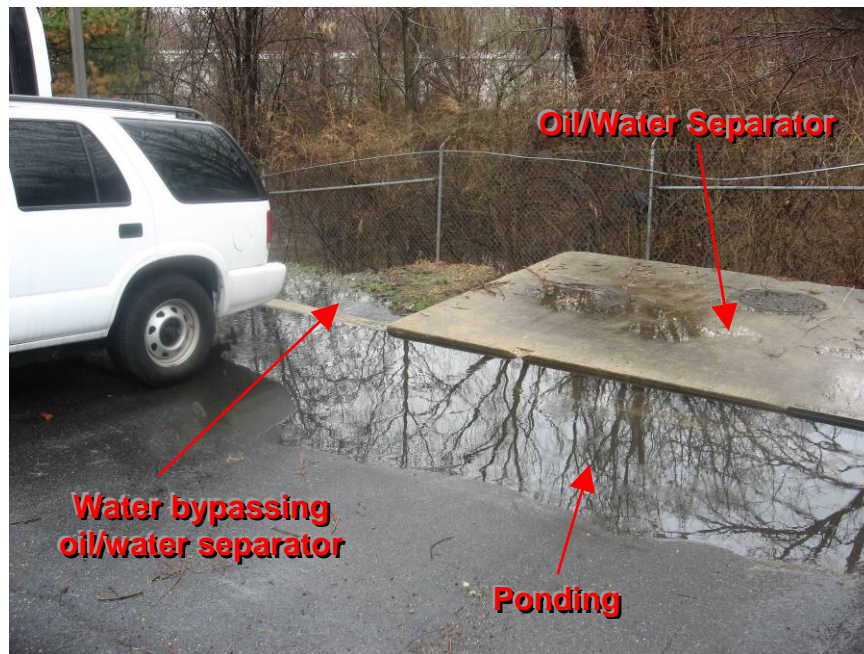
**Photograph 19.** Central Vehicle Maintenance Facility – Oil/water separator on western side of the facility with ponding.

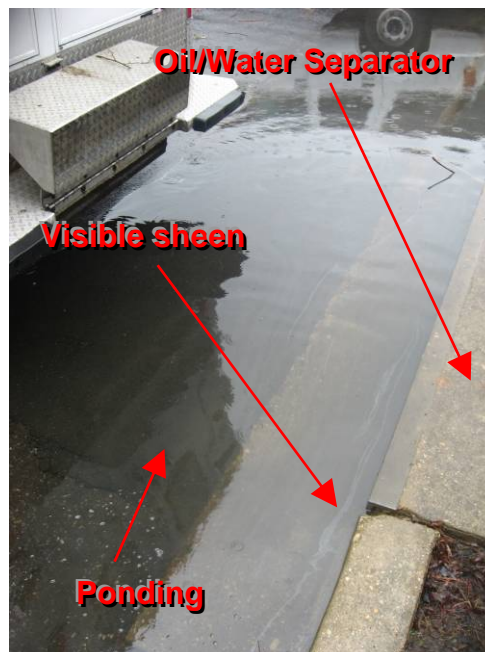
**Photograph 20.** Central Vehicle Maintenance Facility – Close up view of oil/water separator with ponding shown in the previous photograph. Note visible sheen on the ponding water.

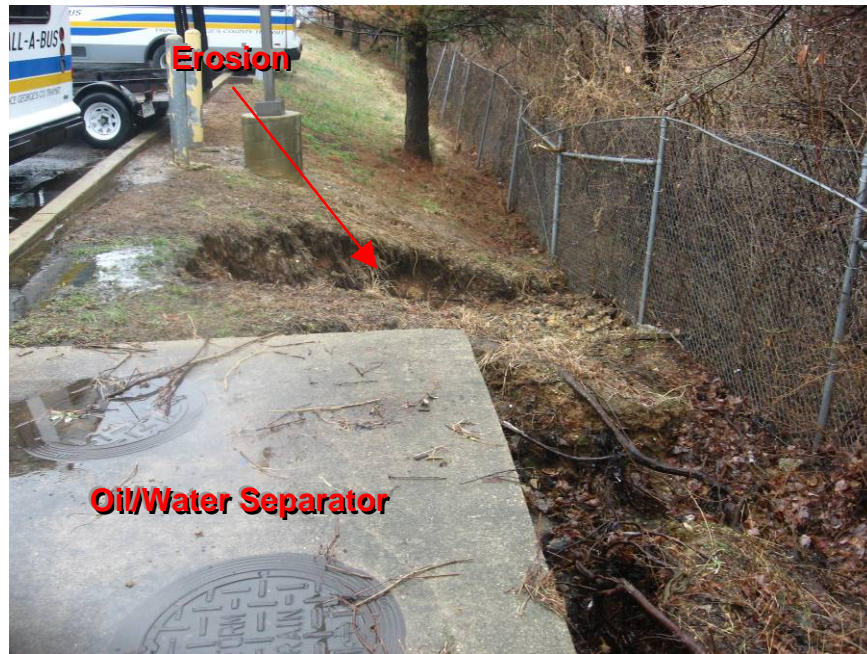
**Photograph 21.** Central Vehicle Maintenance Facility – Significant erosion adjacent to the oil/water separator.

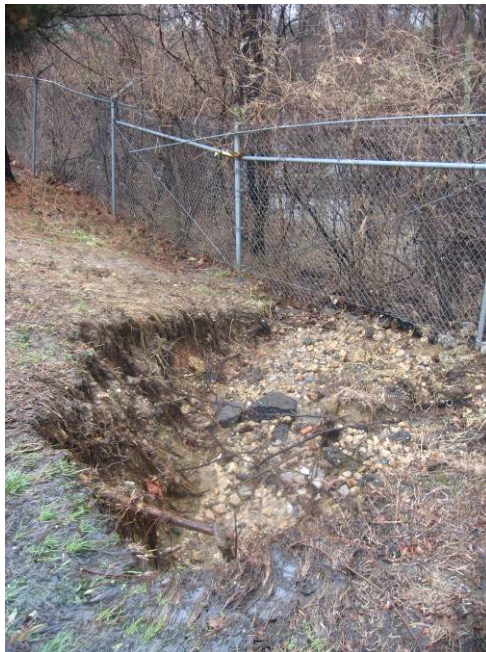
**Photograph 22.** Central Vehicle Maintenance Facility – Close up view of erosion adjacent to the oil/water separator shown in the previous photograph.

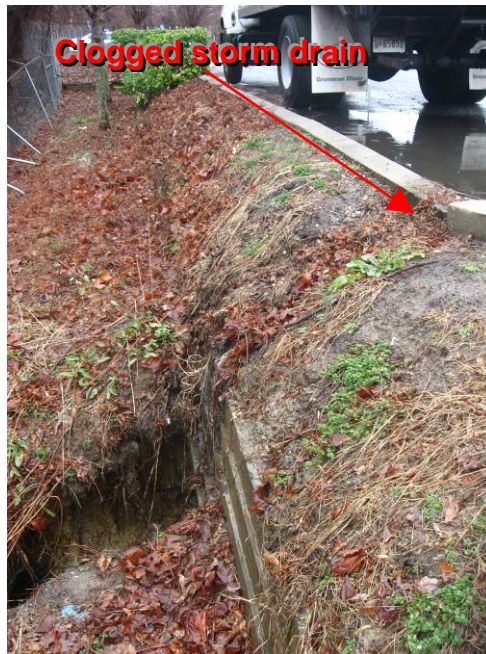
**Photograph 23.** Central Vehicle Maintenance Facility – Erosion along the western side of the property.

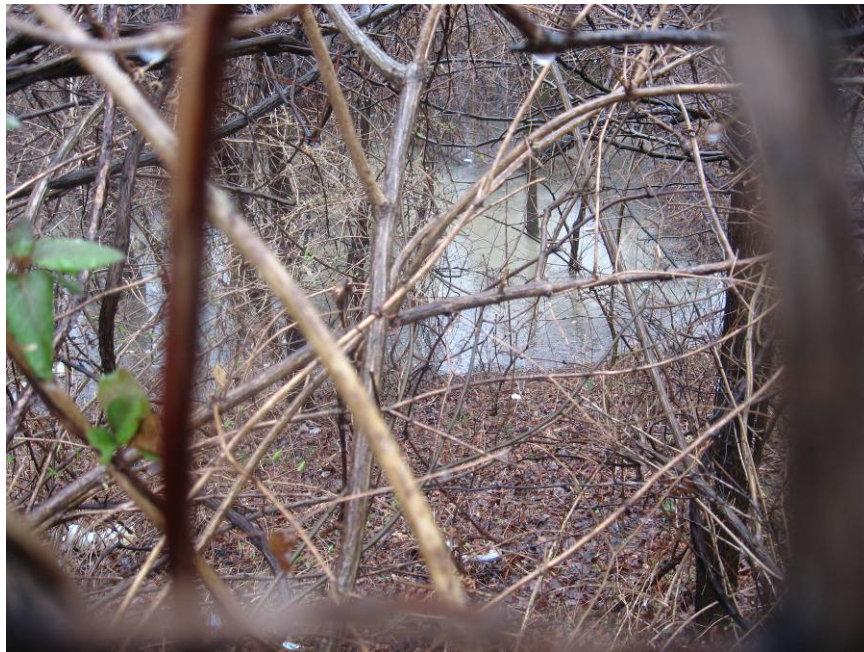
**Photograph 24.** Central Vehicle Maintenance Facility – Stormwater pond filled in with sediment and vegetation on the western side of the facility.

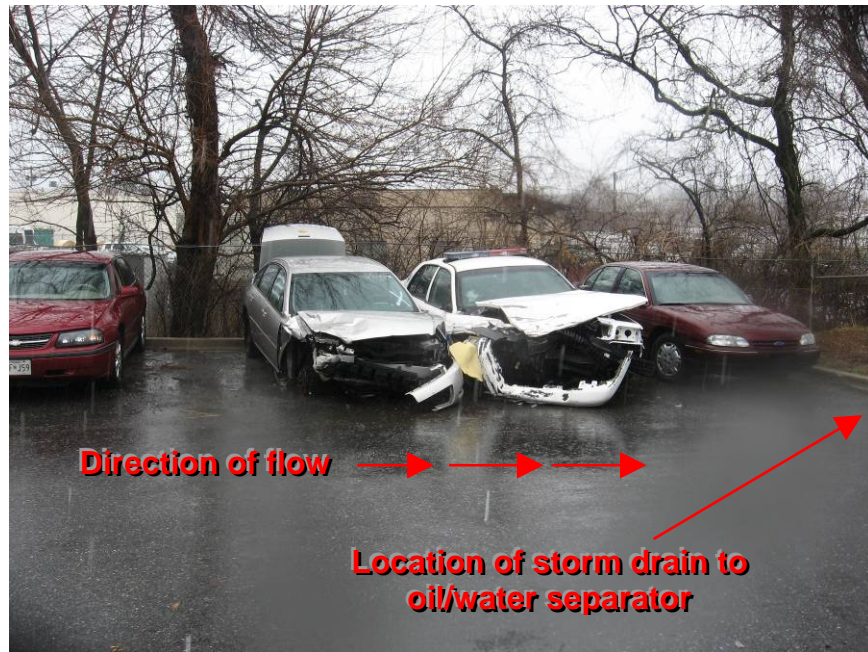
**Photograph 25.** Central Vehicle Maintenance Facility – Vehicles awaiting repair or to be used for parts resting directly on an impervious surface in the southeast portion of the facility near a storm drain. No BMPs including draining fluids have been implemented.

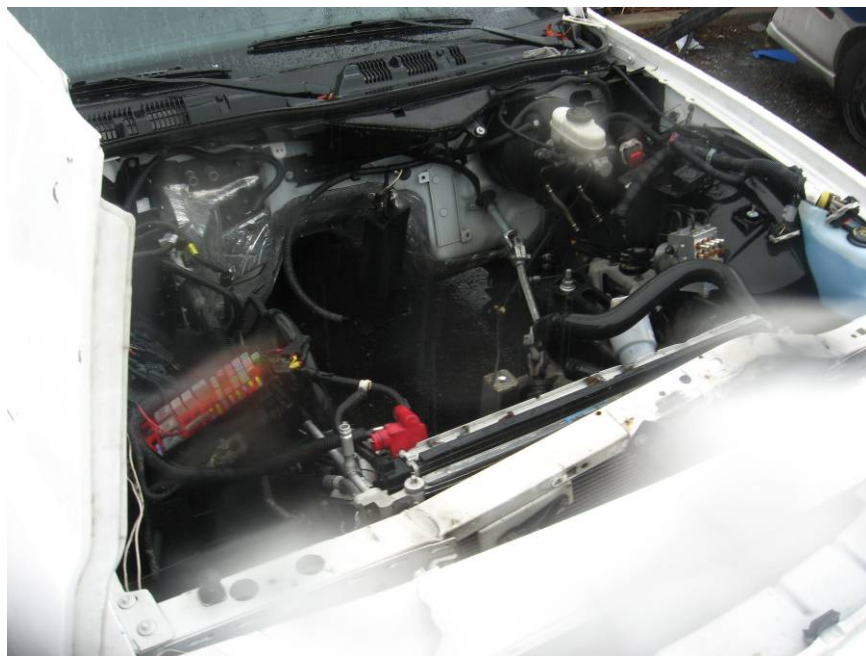
**Photograph 26.** Central Vehicle Maintenance Facility – Vehicle awaiting repair with engine left exposed in the southeast portion of the facility. This area appears to drain to the oil/water separator.

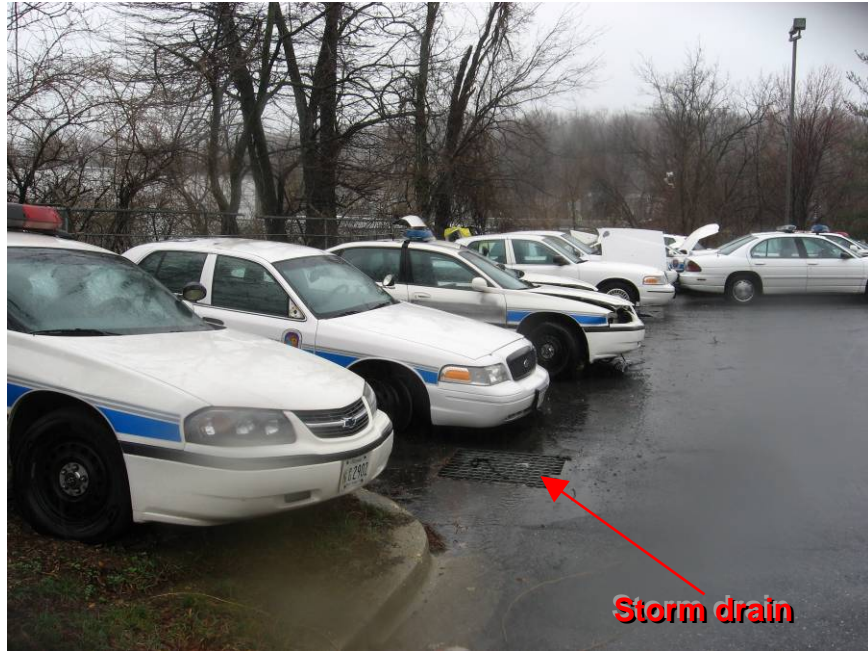
**Photograph 27.** Central Vehicle Maintenance Facility – Vehicles awaiting repair stored adjacent to storm drain to oil/water separator. Note that hoods are up on several vehicles and there are no BMPs in place.

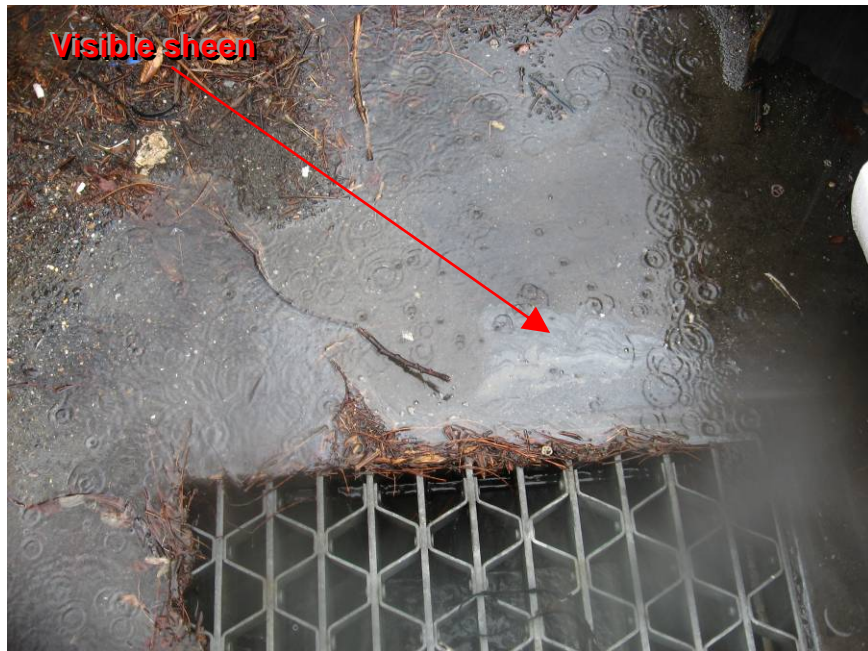
**Photograph 28.** Central Vehicle Maintenance Facility – Close up view of storm drain shown in the previous photograph. Stormwater with visible sheen flowing into storm drain.

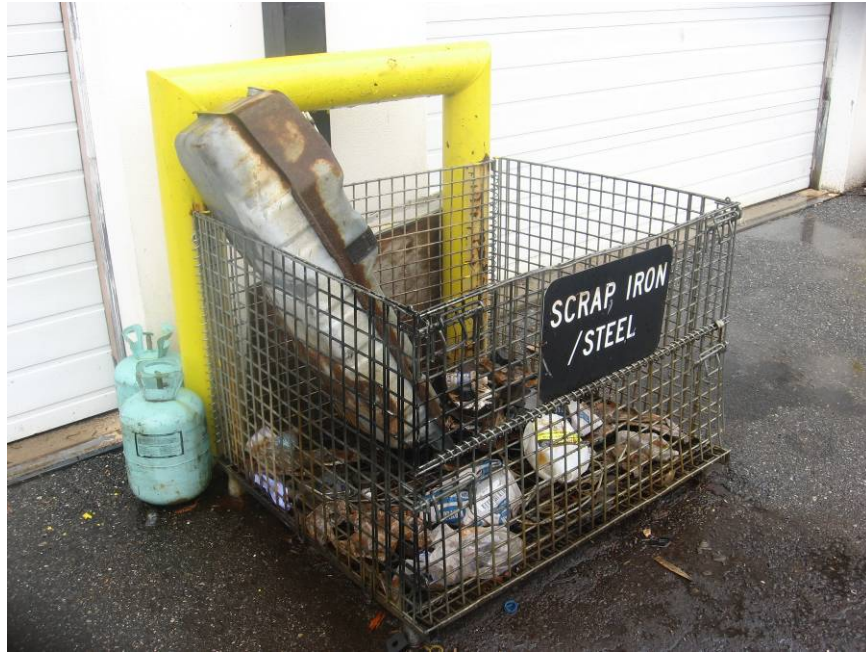
**Photograph 29.** Central Vehicle Maintenance Facility – Scrap iron and steel stored outside and exposed on the south side of the facility.

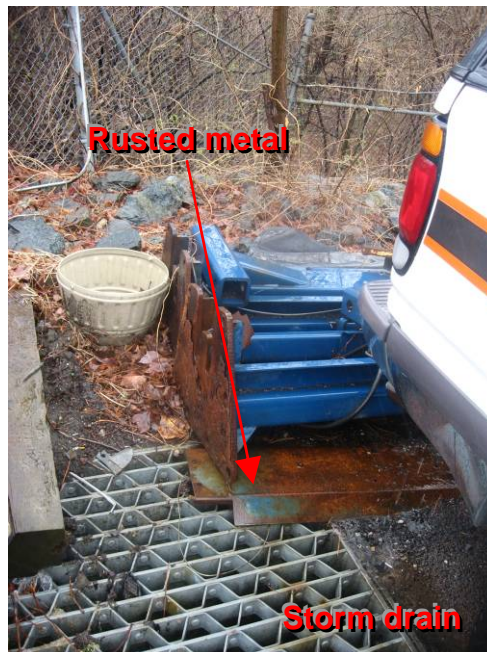
**Photograph 30.** Central Vehicle Maintenance Facility – Rusted metal parts stored directly over a storm drain inlet in the southeast corner of the facility.

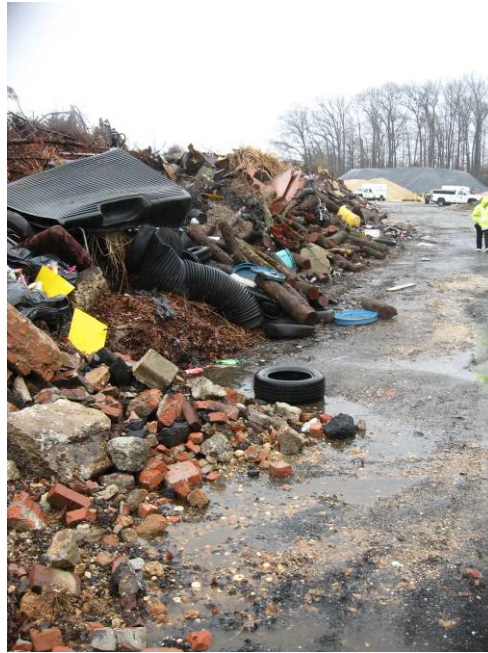
**Photograph 31.**        **Ritchie Service Facility – Trash and debris pile on the northwest portion of the facility.**

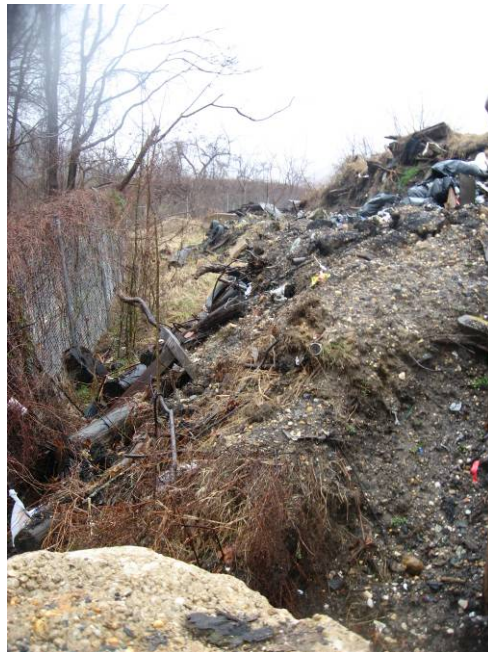
**Photograph 32.**        **Ritchie Service Facility – Another example of trash and debris pile located in the northwest portion of the facility.**

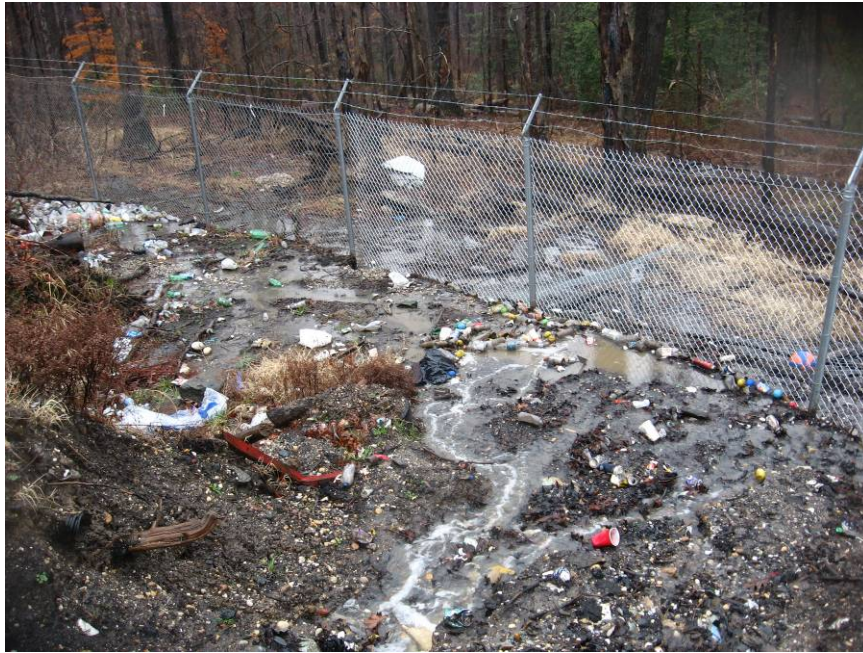
**Photograph 33. Ritchie Service Facility – Flowing stormwater with trash leaving the facility through rills. This portion of the facility discharges to Ritchie Branch 0.2 miles west from the property.**

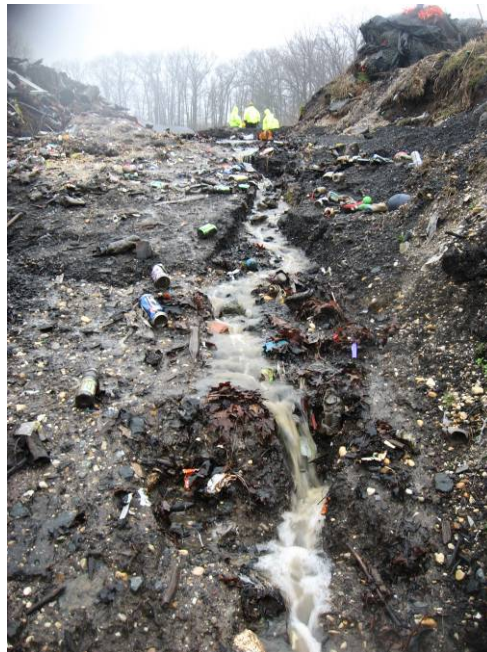
**Photograph 34. Ritchie Service Facility – Rill with flowing stormwater and trash in the northwest portion of the facility. Stormwater discharges to Ritchie Branch 0.2 miles west of the property.**

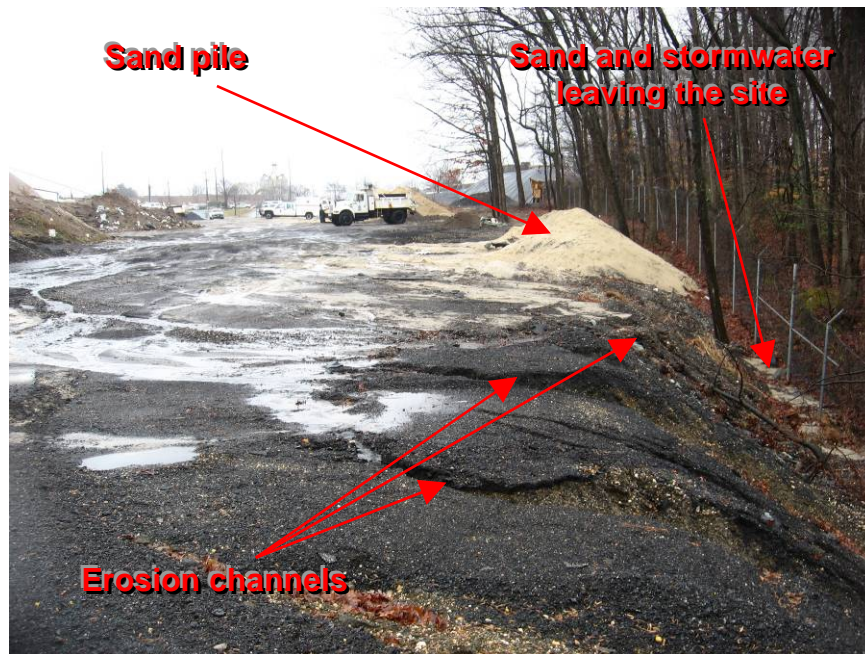
**Photograph 35.** Ritchie Service Facility – Sand storage in southwest portion of the facility along fenceline with erosion channels adjacent to the piles. Sand and stormwater can be seen leaving the facility flowing west through a ditch to Ritchie Branch.

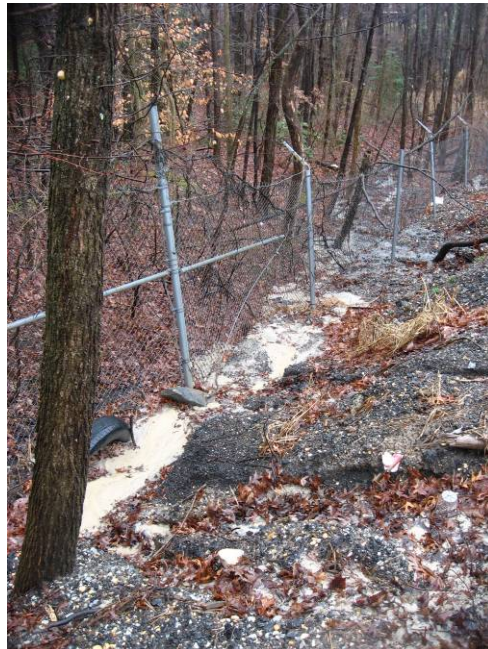
**Photograph 36.** Ritchie Service Facility – Close up view of sand and stormwater leaving the facility and flowing to a ditch to Ritchie Branch as shown in the previous photograph.

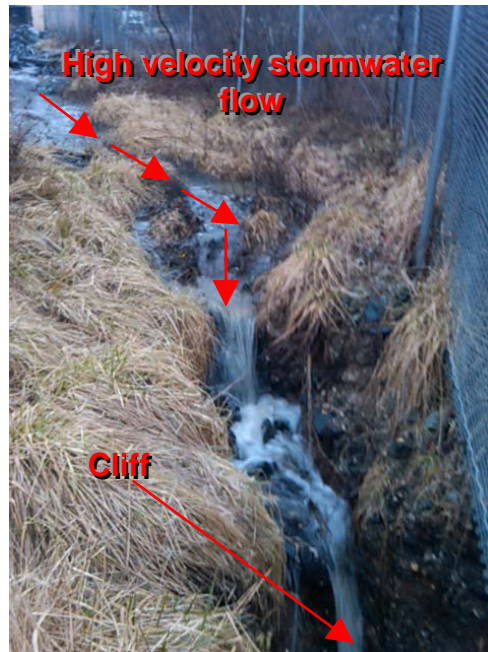
**Photograph 37.** Ritchie Service Facility – Stormwater flow through a large rill in the north central portion of the facility. Water flows under the fenceline down an approximate 15 foot cliff to Ritchie Branch.

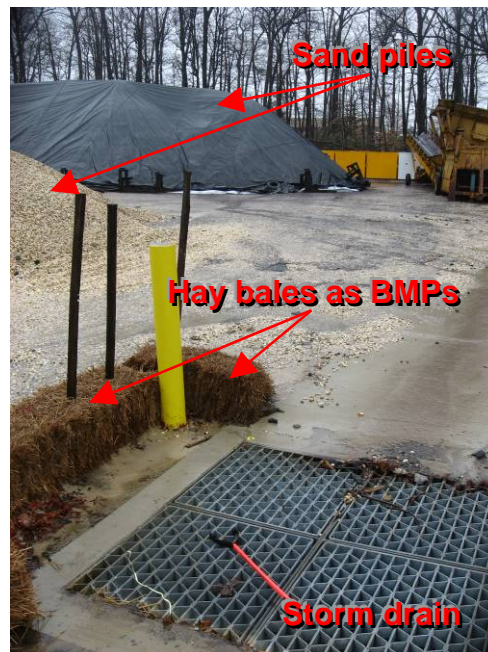
**Photograph 38.** Ritchie Service Facility – Covered and uncovered sand piles in the northwestern portion of the facility adjacent to storm drain that drains through stormwater conveyances to Ritchie Branch. Hay bales in place as storm drain protection.

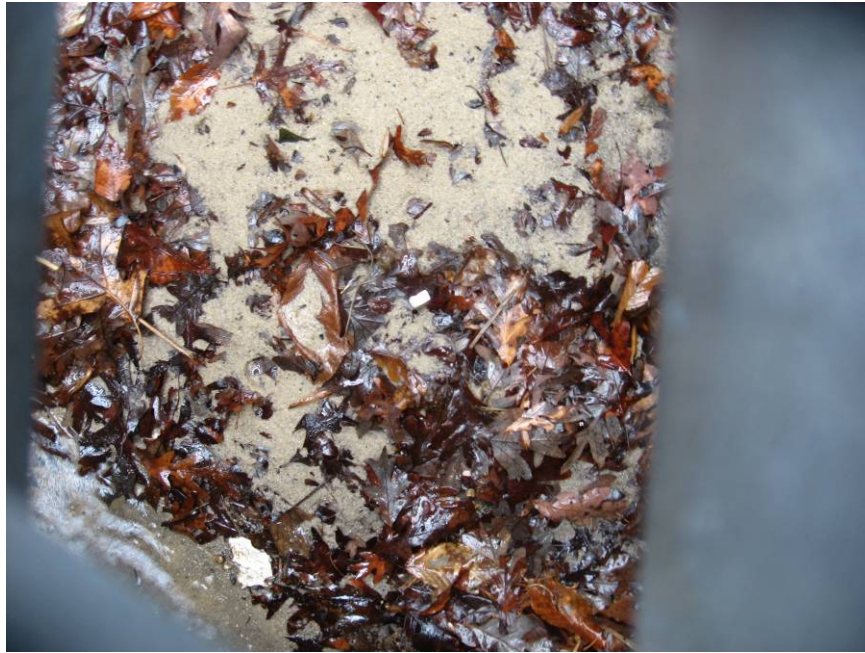
**Photograph 39.** Ritchie Service Facility – Close up view of storm drain in the previous photograph. Storm drain is filled with sand and leaves and drains through stormwater conveyances to an outfall to Ritchie Branch in the southwest portion of the facility.

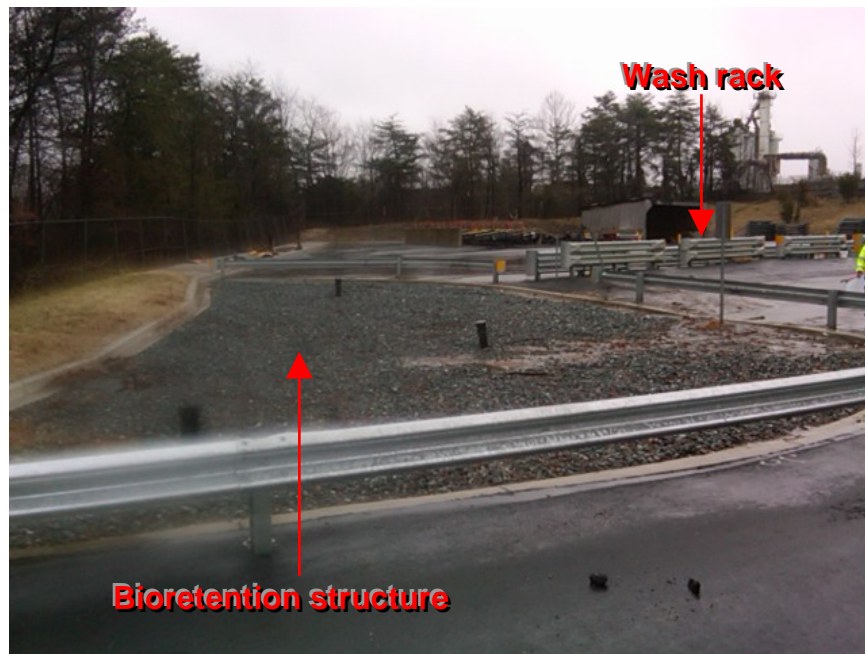
**Photograph 40.** Ritchie Service Facility – Wash rack and bioretention structure in the northeast portion of the facility.

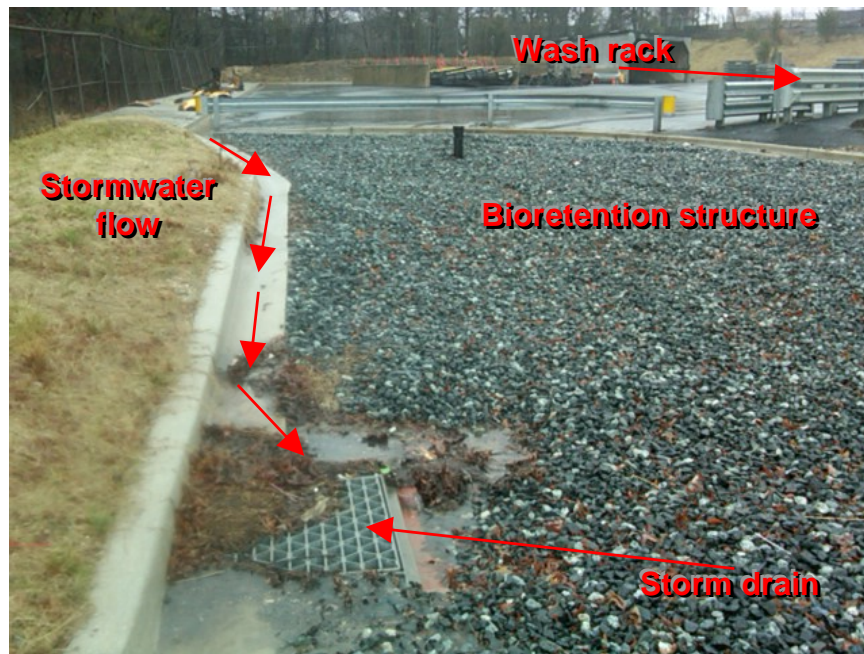
**Photograph 41.** Ritchie Service Facility – Storm drain located in bioretention structure in northeast portion of the facility. Note stormwater flow evident bypassing the bioretention structure and entering the storm drain that discharges to Ritchie Branch.

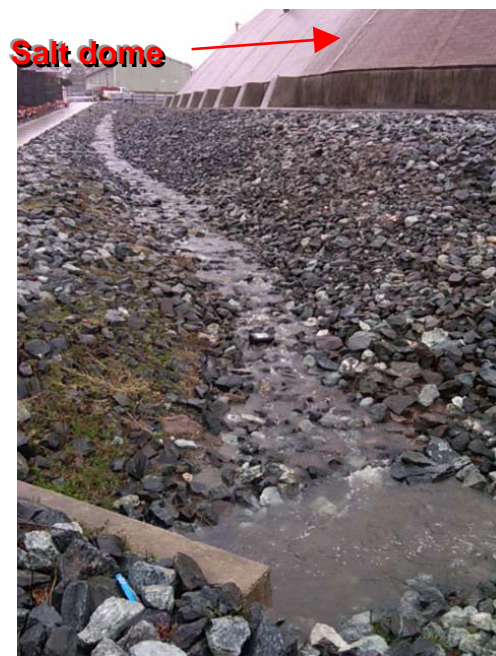
**Photograph 42.** Ritchie Service Facility – Stormwater management control structure surrounding the salt dome.
